# Failure Investigation Report on Different Components of an Automotive Engine

**Abstract:** This paper presents an investigation report of different components failure which affect the performance of an automobile engine. The premature breakage of a four cylinder diesel engine block, crankshaft, camshaft, crankshaft bearing, camshaft bush, engine oil pump was reported. It is found that the failure of each component having the same reason for its failure as reported from different place. Thus it affected the performance of the vehicle and it is very expensive for the customer to replace the damaged parts for several times. In this paper, we presented detailed analysis of the causes for the failure along with preventive suggestion to maintain the engine for better performance.

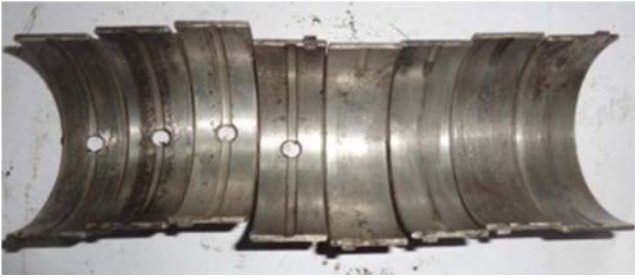
**Figure 3.** Damaged Crankshaft Bearing.

Catastrophic bearing failure can be as a result of both isolated and progressive bearing wear and/or contamination. A progressive failure generally isolates the actual failure towards the end of the engines oil gallery flow, typically rear of the engine assembly.

This can be from both lack of sufficient oil volume and foreign dust, dirt or abrasives and/or metallic particles present in the oil supply. The foreign particles can embed in the soft Babbitt bearing lining displacing metal and creating a high spot as the material is re-plastered to additional bearing materials while the lack of oil volume will cause a wiping of the bearing surface leading to a “Hot-Short” condition. Evidence of either of these conditions will leave some degree

of damage and wear throughout all bearing surfaces with “progressive” damage being exhibited as the oil flow travels through the engine creating more debris.

Engine coolant is what's supposed to keep the overall engine within operating temperature. Water pump should have to check whether there is a leak from the pump. Machine have to be improved in aspect of products forming and process technology. The crankshaft must be strong enough to take the downward thrusts of the pistons during the power strokes without excessive distortion. In most instances, replacing an engine with a cracked engine block is the best solution, particularly if the customer is interested in a salvage engine or a rebuilt engine (both of which are more economical than crate or remanufactured engines).

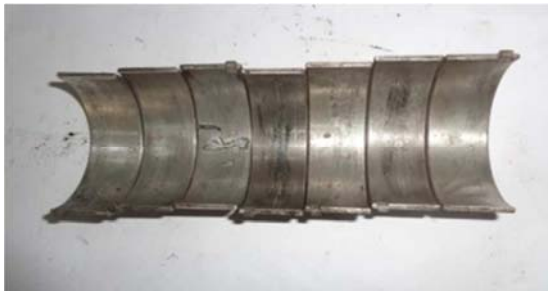
**Figure 4.** Damaged Connecting rod bearing.

Catastrophic connecting rod failure can be as a result of incorrect clearances causing bearing failure, incorrect torque applied to the fasteners, engine over speeding resulting in hyper-articulation of the connecting rods and connecting rod bolt failure.

Incorrect clearances will result in seizure of the connecting rod bearing. Once started, through continued operation, the friction, debris and heat generated by the seizure of that bearing can cause the oil to vaporize and create a lack of lubrication condition commonly shared with its partner connecting rod in V8 applications sharing the same rod journal. The generated heat will remove the hardness from the crankshaft, leaving a blackened appearance. With the continued operation this can lead to the connecting rod to disengage from to crankshaft and collide with the rotating assembly. A series of high energy collisions can create a high degree of secondary damage to the engine assembly.

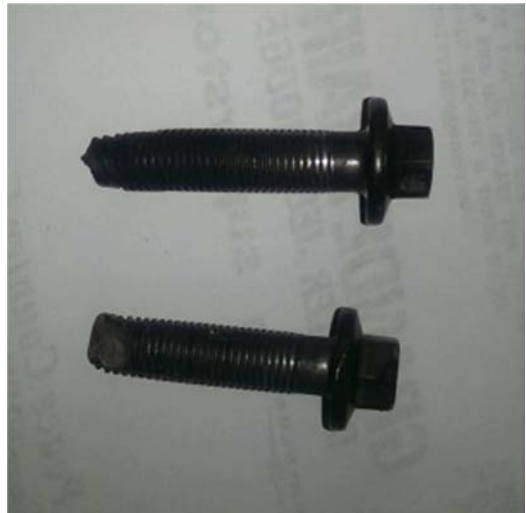
**Figure 5.** Damaged Connecting rod bolts.

Incorrect torque applied to the fasteners can be observed typically by at least one if not both bolts still intact with collateral damage from a subsequent high energy collision within the engine assembly. As most connecting rod bolts require an engineered amount of “stretch” to maintain torque, once loose can work their way out of their threaded end within seconds. This leaves the bearing lacking any evidence of a lubrication or contaminant concern with the crankshaft journal still polished in appearance with only the subsequent collateral damage caused from the connecting rod disengaging from the crankshaft.

Connecting rod bolt failure generally leaves the condition of at least one bolt with the head broken off, the bolt split at an angle down its length and the opposing bolt broken off within the upper connecting rod half. This can result in a sudden catastrophic failure resulting in a high energy collision with the connecting rod, crankshaft and block assembly but will leave the crankshaft and bearing assembly with their previous polished appearance with only collateral damage from the collision being observed.

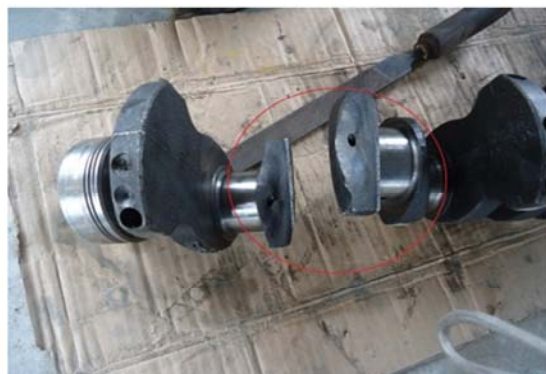
**Figure 6.** Cracked engine block and crankshaft.

Engine over speeding can be as a result of down shifting an automatic or manual transmission in too low of gear for the current vehicle speed, operating the engine at a higher than designed engine rpm from aftermarket tuning and sudden drivetrain failure on a loaded engine causing unregulated engine rpm gains through inertia. As this failure can happen suddenly it typically leaves the condition of a relatively undamaged bearing and crankshaft journal, excluding collateral damage from the resulting high energy collision, but leaves the threaded end of the connecting rod bolts in the upper connecting rod assembly. This is possible from the bolts achieving their tensile stress point and break at the mating surface where the cap meets the connecting rod.

Failure of bearings and rods from contamination and/or oil flow issues are generally as a result of failure to replace an oil cooler from a previous engine failure, inadequate oil amount, missing oil gallery plugs, worn oil pump and blocked oil galleries. Incorrectly torqued fasteners will generally cause failure within the first few thousand kilometres/miles and failure as a result of engine over speeding typically shears both rod bolts off flush the machined or fractured connecting rod joint.

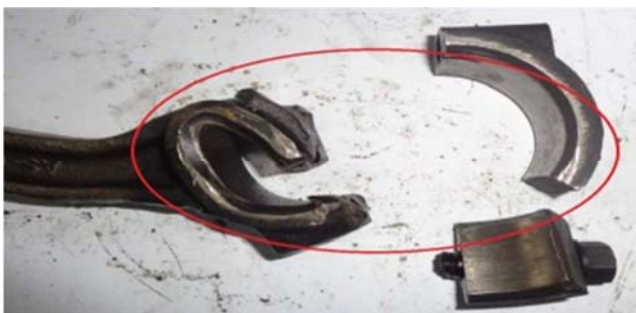
*Figure 7. Bent Connecting rod.*

Hydrostatic lock occurs when a volume of liquid greater than the volume of the cylinder minimum (end of the pistons stroke) enters the cylinder. Since most common liquids are incompressible the piston cannot complete its travel; either the engine must stop rotating or a mechanical failure must occur. Diesel engines are more susceptible to hydro lock than gasoline engines. Due to their higher compression ratios, diesel engines have a much smaller final combustion chamber volume, requiring much less liquid to hydro lock. Diesel engines also have higher torque, rotating inertia and

stronger starter motors than gasoline engines. The result is that a diesel engine is much more likely to suffer catastrophic damage from ingestion of incompressible fluids.

Typical causes of this concern is from ingestion of fluids through the intercooler, water in fuel and improper torquing of injector hold down bolts.

As the hydrolock mainly occurs when driving through floods, either where the water is above the level of the air intake or the vehicle's speed is excessive. Excessive fuel entering (flooding) one or more cylinders in liquid form due to abnormal operating conditions can also cause hydrolock. Thus the customers should have to be advised for not run the vehicle through standing water or heavy precipitation. Always have intercooler and piping professionally cleaned when installing a new engine and follow the original equipment manufacturers recommended torque sequences. If a water in fuel light comes on vehicle should be towed, not driven to a dealer for further inspection.

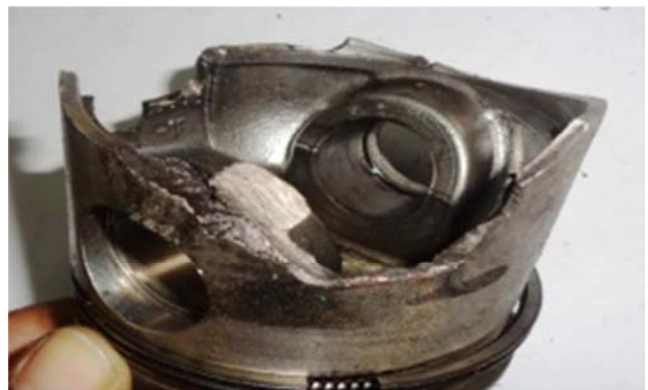
*Figure 8. Cracked Piston.*

Cracking of the piston crown around the combustion bowl will display radial cracks at the bowl rim on direct injection diesel engines. This is caused from a premature or excessive fuel injection to cause high thermal and mechanical loads causing fatigue as the piston is bent around the wrist pin as it drives the piston through the compression stroke in the presence of excessively high cylinder pressurization and thermal stress. When this occurs the most heated part of the combustion chamber, surrounded by less heated regions, can't expand in accordance with its expansion coefficient at high temperature. Because the material cannot compress the only way is to expand in the direction of a free surface. A plastic deformation occurs from the accumulated material which once the piston cools, the deformation persists, resulting in tensile stresses which lead to cracks at the combustion chamber corners. The wedge effect in conjunction with the presence of quick changes in temperature fatigues the piston in this area causing the piston to fracture.

Excessive high cylinder pressurization can be the result of malfunctioning fuel injection, advanced fuel injection timing or hydrostatic lock. To reduce the risk of this happening DFC can remove the lip in the combustion bowl helping to prevent radial cracks that can form from extreme thermal tensions.

The EGR valve operation have to inspect for carbon buildup and clean as needed. Also the cylinder pressure have to check, as well as advanced fuel injection timing should inspect.

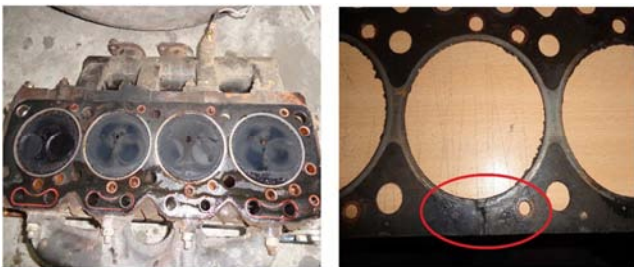
Figure 9. Cylinder head & Head gasket.

The root causes for many of these failures are unrelated to the sealing joint itself and cannot be detected by an examination of the cylinder head gaskets alone. Cylinder head gasket failures and other engine damage occurring in these engines have found to be directly linked to hydrostatic lock from injector and EGR cooler failures. Another very common root cause for cylinder head gasket failures in this engine are as a result of excessively high cylinder pressures through the utilization of aftermarket performance tuning programs. To produce a viable seal, the gasket relies on an even application of adequate amounts of clamping force. The excessively high cylinder pressures produced by aftermarket performance tuners and hydrostatic lock effectively lift the cylinder head off the cylinder block reducing clamp load applied to the gaskets, breaking the combustion seal and initiates leakage.

Extensive damage caused by a blown head gasket can be the most detrimental form of engine problems. If a faulty head gasket is not detected early, a required repair of the engine block, the cylinder head, or a complete engine replacement could be required. Coolant can leak into the combustion chamber and can cause abnormal smoke emissions. This issue alone, for example, could likely result in having to replace the catalytic converter.
