# The Solution of the Overvoltage Damage for IMS's Microseismic Monitoring System

Chen Ruxiu, Liao Hua. The Solution of the Overvoltage Damage for IMS's Microseismic Monitoring System. *International Journal of Mechanical Engineering and Applications*. Vol. 6, No. 4, 2018, pp. 98-103. doi: 10.11648/j.ijmea.20180604.12

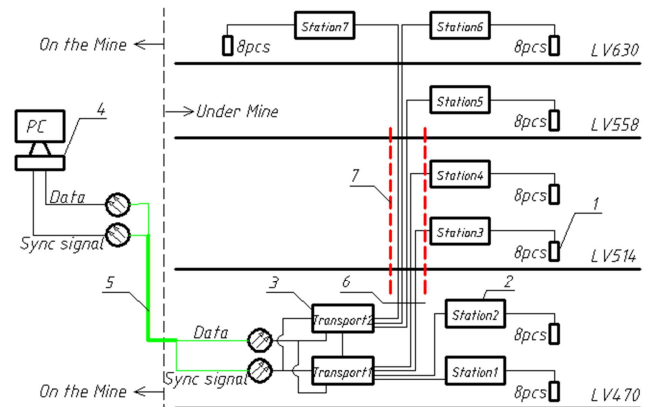
Figure 1. IMS System Architecture Diagram.

sensor 2, station 3, transport 4, server pc 5, optical cable 6, copper cable 7, meter single shaft

The system architecture is shown in Figure 1: a total of 7 stations are arranged on 4 levels. Each station receives 8 sensors, total 56 channels. The system uses a star distribution to transmit data to the transmission port(modem) by DSL communication, and the data is uploaded to the server (the surface host) by the transmission port, and at the same time the server simultaneous signals are also transmitted through optical cables to the transmission port. The modem has the function of coupling the simultaneous signals to the DSL port connected to the station. The IMS station is composed of four modules: UPS, ADC, SP and DSL modem. All the sensors are connected to the ADC module. SP is responsible for collecting, triggering and controlling, and DSL modem is responsible for data transmission.

Fiber optic cables are used to connect the ground server and the underground transmission port, and different copper-core signal cables are used to connect the station to the transmission port and the sensor to ADC. There are instrument wells, traffic laneways or vertical boreholes between the different levels sections.

Fault B, We can clearly visible from picture in Figure 2 that the RJ45 interface of high voltage breakdown and blackening. The transmission port of LV470 and levels section DSL modem are the same. Combined with Figure 1, can found that the copper core cable between the modem and transmission ports passes through the instrument well, and there is no Figure 2 failure phenomenon before the 10KV cable laid in 2015. Once the 10KV cable insulation reducing or environmental changes, the electric faults such as leakage, flashover, short-circuit and other electrical failures occur, a strong electromagnetic field around the 10KV cable causes a high voltage near the conductor [14, 15]. Although this type overvoltage is not like the lightning overvoltage, but the energy is large enough to burn the electronic equipment, IMS equipment in this system is caused by this induced overvoltage.

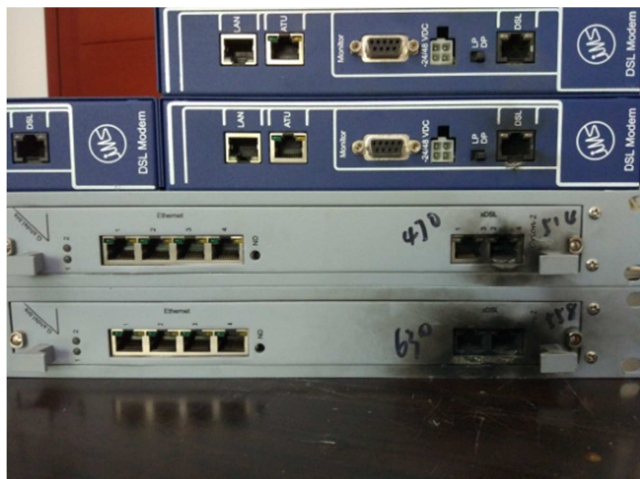
Figure 2. The Damage Equipments.

burned down and the transmission port of the LV470 chamber was burned down in time. Failure features such as Figure 2. Forcing the IMS microseismic equipments to stop running. Fault C: during the stop operation of the IMS system and 10KV cable is still next to the transmission cable, the interface on the transmission port also burned out, with the same as Figure 2.

Base on high reliability of the power supply of TT grounding system, this kind of power supply scheme is basically adopted in domestic mines. The solution of the offset of neutral point is to use a 380/220V isolation transformer, using the characteristic of maintaining the balance of line voltage when the TT system is grounded, the original single-phase power supply is replaced by a two phase power supply, that is, the isolation transformer voltage of 380VAC side connection two phases of power system, the 220VAC side power supply with stable output is supplied to the monitoring equipment. The scheme greatly improves the reliability of power supply, and the grounding fault occurs in the underground power system. As long as the power supply

The way to cut off the overvoltage transmission pathway and prevent overvoltage come into being is the most effective way to prevent induced overvoltage. For the inevitable 10KV high voltage cable in the instrument well, using the advantages of optical fiber resistance to strong electromagnetic interference, the common DSL communication mode of IMS system is changed to Ethernet communication mode. It does not induce high voltage on the optical fiber line, completely excision the generation and propagation of induction overvoltage, so as to ensure the safety of the equipment. In the system, the power supply and sensor are also connected to the equipment by copper-core cables, can not be replaced with optical cables. These are all possible and interfering factors to produce and conduct overvoltage. So cables laying must avoid power cable or high voltage cable as far as possible. When it is impossible to avoid laying such as parallel and vertical laying should be strictly observed the safety distance provided by the regulations or rules.

The microseismic system of the Shizhuyuan mine has set up four levels section of 470/514/558/630. After the failure, the rectification measures are: 1) The power supply of the microseismic monitoring system add a set the 380/220VAC isolation transformer. 2) And the grounding system has been set up. The grounding system is designed and constructed in accordance with the pattern plate in Figure 4, of which levels 514/558 monitoring chamber is connected with the existing grounding grid. 3) The system adds a surge protector, and the configuration is as follows: the class II protector is set in the power box of the microseismic system, and the class IV to device - safety isolation module is reconfigured between sensors and ADC. At the same time, it is suggested to set up class I protection module in the low voltage(380V) main power transformer. 4) The data transfer cables to all fiber transmission. 5) The cable laying in the tunnel is arranged according to the regulations or rules.

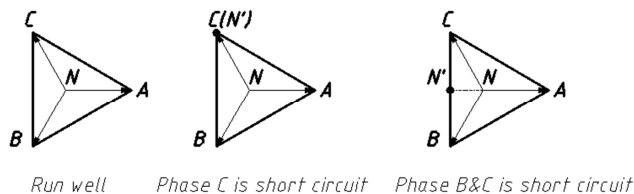
Figure 3. Voltage vector diagrams.

The failure A is that IMS system UPS module, ADC module outside is in good condition, but can not work again. Then send back to the original factory maintenance. Through the original factory inspection, the report is the main chip burned. Fault analysis: First, the fault occurs when the time is after the rework, the mining equipment insulation reduce during humid environment and many leakage phenomena occur. Secondly, the equipment 220VAC power source is from a fire line and a null line on the power bus of the underground power system, a voltage regulator transformer and UPS. Third, be confirmed, underground power protective grounding system is TT modem (neutral point ungrounded system) [10, 11]. Comprehensive three points analysis can be obtained: fault A is the neutral point drift caused by neutral point ungrounded system [12], for example, the N point shown in Figure 3 is the neutral point position in the normal period. When the fault occurs, the position of the neutral point is drifting to  $N'$ , resulting in the increase of the phase voltage. The maximum steady state overvoltage of the single phase short-circuit of the TT system is  $1.732 U$ , the maximum transient overvoltage (high frequency oscillation, voltaic arc intermittent extinction and reburning) is  $2.5U$  in the first time voltaic arc burning, and is up to  $3.5U$  in voltaic arc again

burning [13]. So 220VAC voltage supply direct come from two phases by TT system mode is easy to cause equipment damage due to overvoltage. This is the typical internal overvoltage caused by neutral offset, and it is also the fundamental reason for burning the IC inside the module.

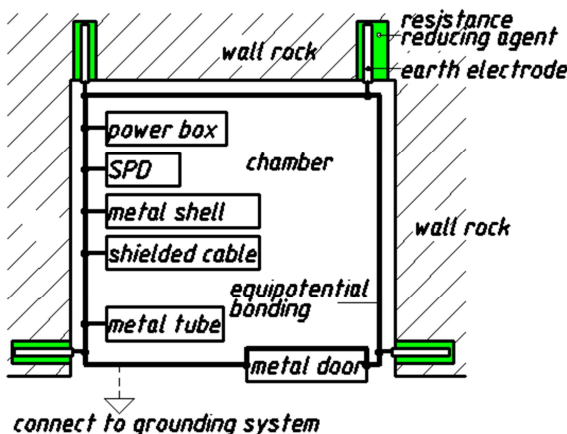
Figure 4. Earthing System Schematic.

To adopt the lightning protection measures and reduce the insulation configuration, it is necessary to perfect the grounding system and select the appropriate surge protector. The grounding system underground chamber construction is shown in Figure 4. The underground monitoring chamber grounding system is composed of grounding device and grounding grid, and surge protection device. Doors and windows, railings, metal components, import and export protection pipe, metal case shell, equipment metal shell, cable shield layer, surge protector and so on are connected or welded with the shortest distance with equipotential bonding. Each part is connected to the same potential and is not connected in series. Equipotential bonding (grounding grid) is the main device to ensure that equipment is free from overvoltage damage.

The repeated grounding device for underground monitoring chamber can be buried in the chamber around the chamber, fill the ground pole, fill the drop resistance agent in the hole, and weld the ground electrode directly on the equipotential line, the equipotential row must be connected with the underground main grounding grid reliably [18], such as the Figure 4. The

underground chamber and the surrounding of the mine are composed of high resistivity rock. The power supply system uses neutral point ungrounded form, the leakage current is very small, the chamber set up equal potential connection, the equipment and personnel have safety protection. The grounding device is designed to release the energy of the overvoltage by the surge, and the repeated grounding resistance has no specific resistance. Under some conditions do be lower the grounding resistance.
